The Measured Impact of Erosion on the Rotodynamic and Performance Characteristics of a Mixed Flow ESP

Gerald L. Morrison

Professor of Mechanical Engineering
Texas A&M University
College Station, Texas USA

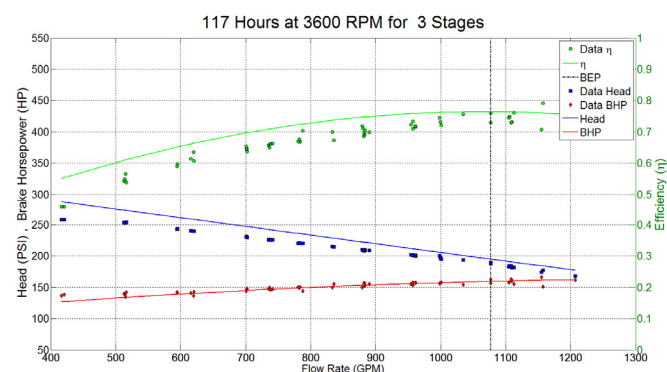
Figure 4. Pump performance change due to 117 hours of erosion.

The three performance parameters that were monitored through the 117 hours of erosion testing are efficiency, power, and total head. The general performance is shown in Figure 4. The figure compares the pump performance after 117 hours of erosion in plotted dots to the baseline data shown in solid lines. The mean efficiency dropped 6.8% and the pump's mean total head dropped 6.3% after 117 hours of erosion testing. However, the mean power consumption did not show much change with a 0.5% increase. This indicates that the impellers are still supplying a relatively constant amount of energy to the fluid flow. For this pump, the seals wore significantly while the main hydraulic paths showed only minor erosion. It is therefore concluded that the decrease in head was due to increased leakage from each stage's exit to its inlet by way of the secondary flow paths. Details of the hydraulic paths wear are included later in this paper.

The wear measured or captured after 117 hours of erosion testing had a direct impact on the pump's performance. The pump's overall efficiency dropped 6.8%, the total delivered pressure rise across three stages fell 6.3%, the best efficiency point dropped 0.8% and the electric power consumption increased 0.5%. These results indicate that the pump is consuming more power to deliver lesser pressure rise and efficiency than the base condition. The primary cause to the drop in pressure rise is the recirculation of the pumped fluid through the secondary flow paths due to the larger bearing and impeller seals' diametric clearances. The primary goal of the labyrinth seals is to minimize reverse flow and recirculation of the operating fluid in the stages. The significant clearance change in the seals causes an increase in each stage's leakage and consequently dropped the pressure rise across each stage which in turn affected the entire performance of the pump. Another reason the pressure rise in the pump decreased with erosion time, but is not as significant as the wear in the impeller seals, is the erosion of the primary paths including the impeller and diffuser vanes and walls. The changes in shape and dimension will increase the probability of eddies occurring in the primary flow path causing the loss of energy in the system. Signs of wear caused by these eddies is found on the impeller and diffuser walls, vanes and vane leading and trailing edges

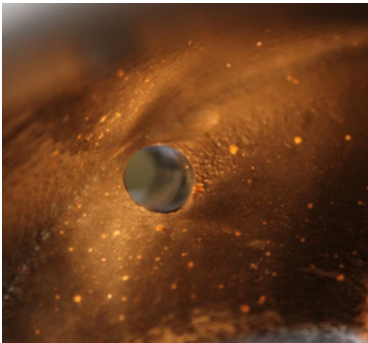
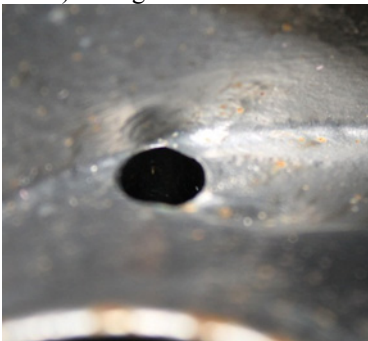
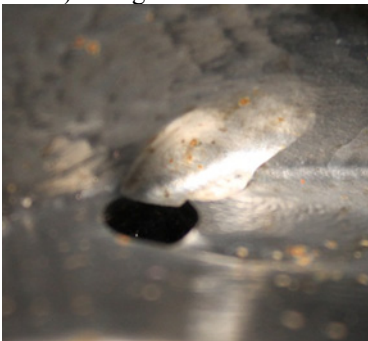
Figure 10. Impeller Balance Holes Intake Side after 117 Hours

The original impeller balance hole conditions are shown in Figure 9. Figure 10 illustrates that a groove due to erosion after 117 hours occurred on the main hydraulic flow side of the impeller. This groove is caused by the wake that is present behind the jet of fluid passing from the high pressure region behind the impeller into the main flow, much like erosion around bridge piers. The size of the groove changes from one stage to the other. Stage one has the smallest groove at the balance hole. Stage number two has a larger groove caused by erosion and stage number three has the largest groove due to erosion.

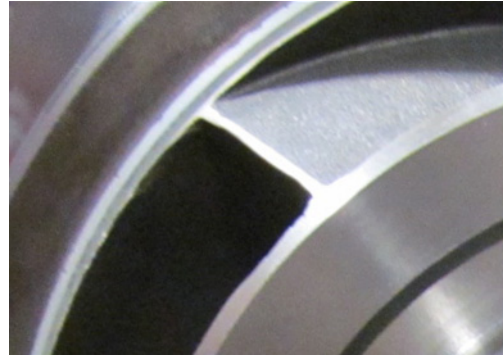
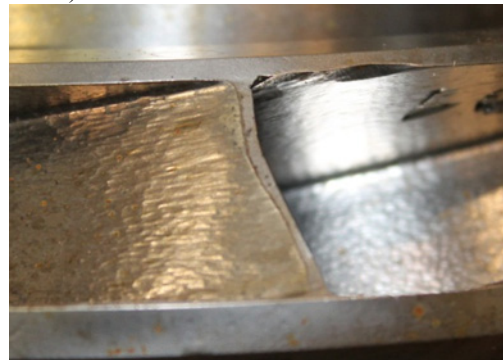
Figure 11. Impeller Blades Base Condition before and after 117 Hours of Erosion

The impeller erosion is visible on the impeller blades and walls. After 117 hours the blade tips are not straight (curved) and the blade edges became slimmer and sharper (Figure 11). The impeller walls are shiny due to the impinging effect of erosion. The walls also have signs of wear caused by the sand and eddy currents in the main flow paths.

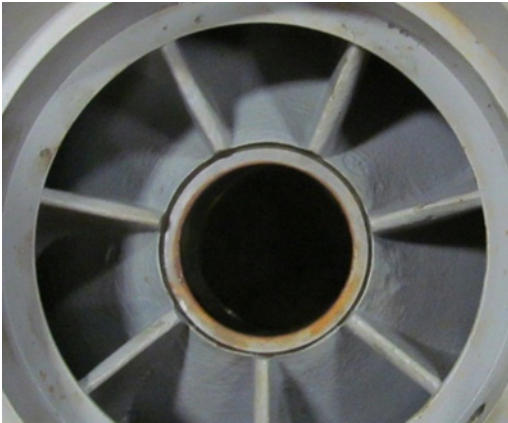
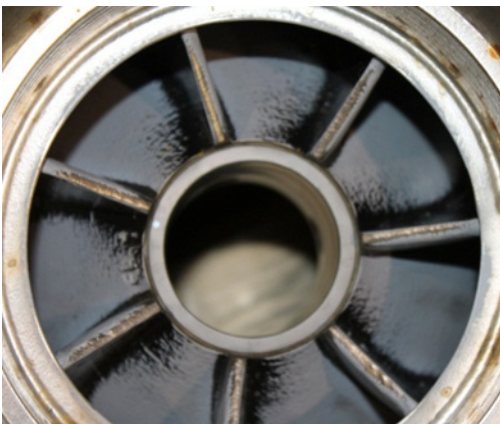
Figure 12. Diffuser Discharge at Base Condition (top) and After 117 Hours

The diffusers primary flow path ways were painted at the start of the test to help visualize the areas affected by erosion. Figure 12 shows the initial condition on the top. Erosion affected the diffusers blade tips causing the ends to be round and smooth. The amount of erosion on the pressure side of the blades was more than the suction side. The diffuser walls lost all paint. The walls became smoother with signs of wear caused by the abrasive and the eddy currents produced in the main flow paths. The diffuser hub lost paint at areas that are on the pressure side of the diffuser blades.

Another example of impinging wear occurs on the diffuser blades causing more wear on the blades' pressure side than on the suction side. The flow around the blades has higher velocities on the suction side than on the pressure side and this should have given more wear on the suction side than on the pressure side. Opposite to the expected fluid dynamics general expected results, the solid particles in the fluid do not always follow the fluid's trajectory. In the mixed flow ESP pump the abrasive particles gain momentum due to the centrifugal forces and once they exit the impeller the abrasives impinge the diffuser's pressure side of the blades explaining the higher rate of wear seen.

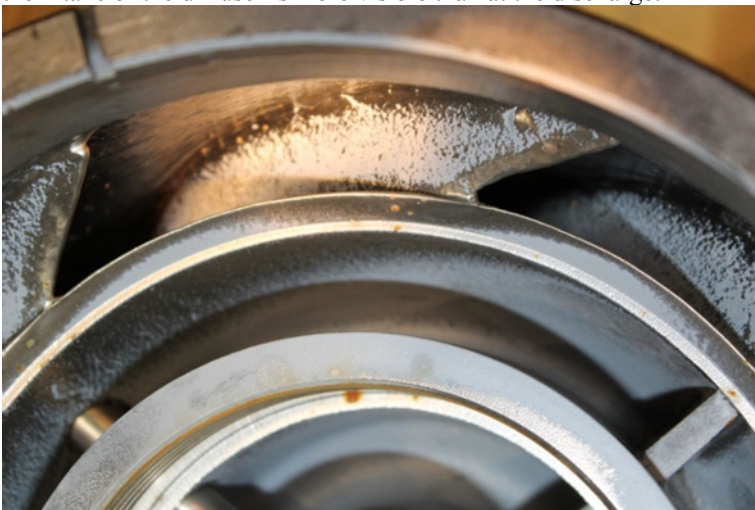
Figure 13. Diffuser Intake after 117 Hours

After 117 hours the intake of the diffuser is presented in Figure 13. The diffuser walls are smoother with impinging erosion marks. The leading edge of the diffuser blades are curved with more signs of wear near the wall and hub. Wear at the intake of the diffuser is more visible than at the discharge.

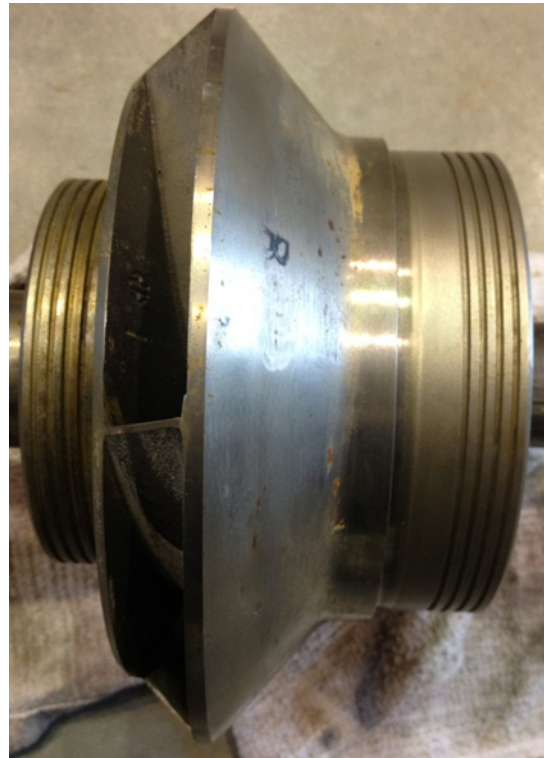
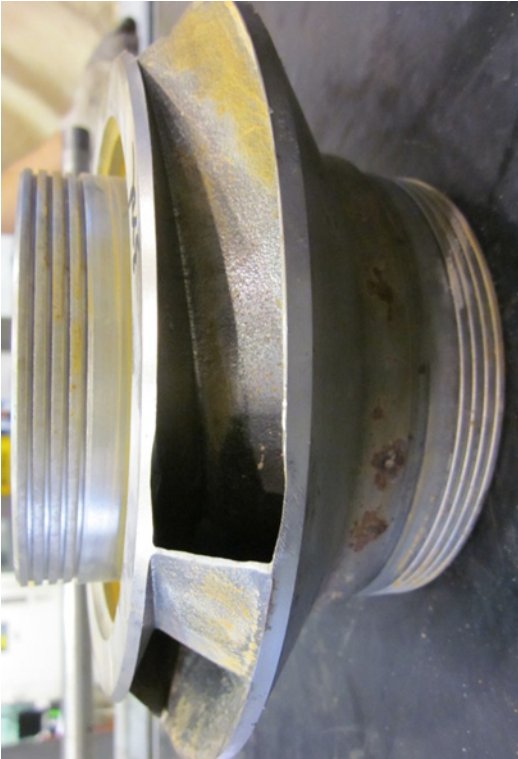
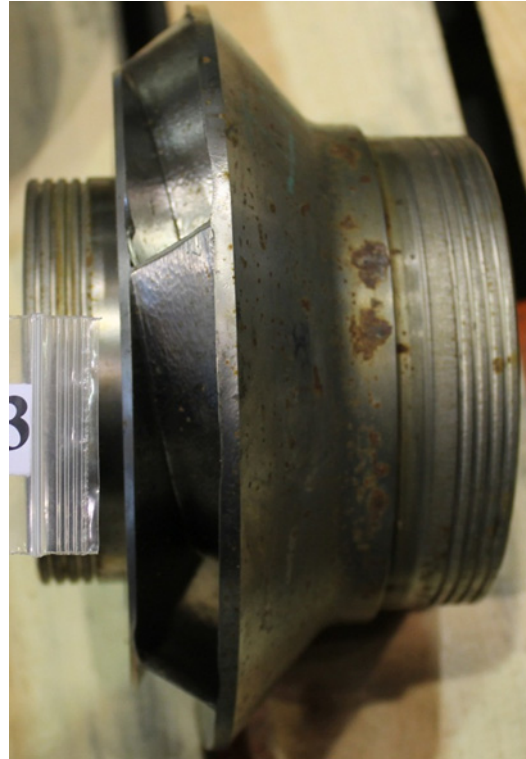
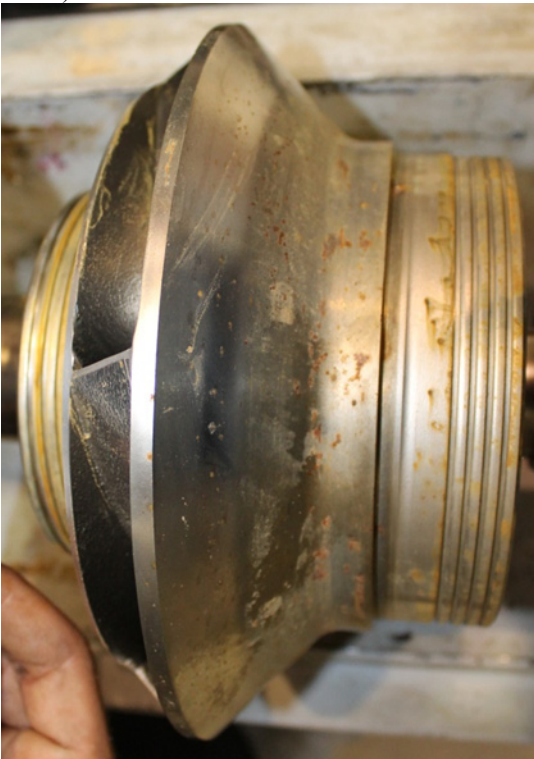
Figure 14. Impeller three Condition after 8, 24, 56 and 117 Hours

The impeller was originally coated with the yellow coating shown in Figure 14. This is an abrasion resistant coating placed on the impeller seals by the pump manufacturer to mitigate the rate of wear. After 24 hours this coating on all stages was completely eroded. The impeller seals wear due to erosion causes the seal clearances to increase and the seal grooves to be shallower as later discussed in this section.

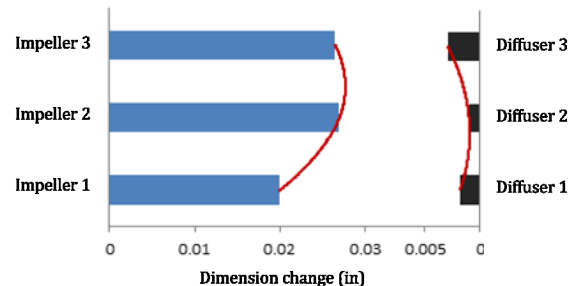
Figure 15. Impeller Discharge and Diffuser Intake Change in Dimension after 117 Hours

The impellers discharge and diffusers intake labyrinth seal erosion is documented by the amount of material removed by erosion. These results are shown in Figure 15 where the values represent the decrease in impeller seal diameter and increase in the diffusers seal diameter. The combined value is the increase in diametrical clearance of the seal. The diffusers change in dimensions are negligible when compared to the impellers. Location affected the impellers rate of wear. The amount of wear in impeller 1 (pump inlet) is slightly less than the wear in impellers 2 and 3.

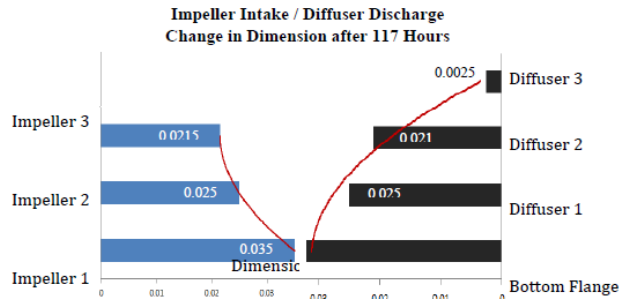
Figure 16. Impellers and Diffusers Wear Modes by Location (2)

The impellers intake and diffusers discharge labyrinth seal changes in diameter are shown in Figure 16. The location of the impeller directly impacted their rate of wear as seen in Figure 16 where impeller 1 had the highest amount of wear followed

by impellers 2 and 3. Diffusers 1, which is coupled to impeller 2, had the same amount of dimension change as impeller 2. Diffuser 2, which is coupled to impeller 3, also had the same amount of dimension change as impeller 3. The diffusers rate of wear is also affected by location where diffuser 1 had more wear than diffuser 2. The 3rd diffuser is not coupled to an impeller. It had a negligible amount of change after 117 hours of erosion.

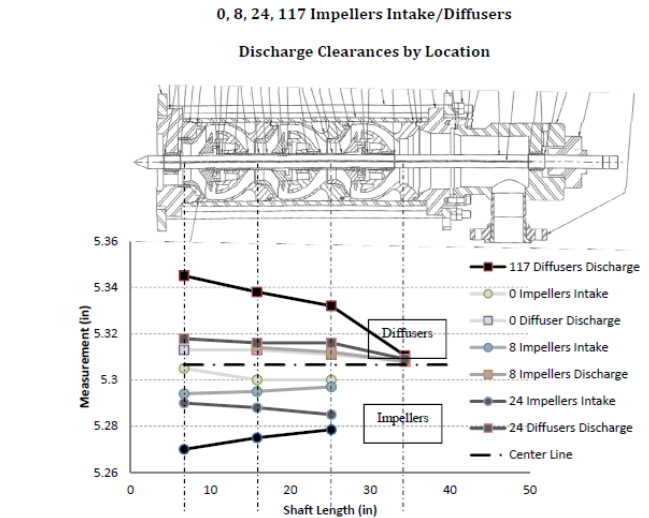
Figure 18. Impellers and Diffusers Evolution by Location (2)

Figures 17 and 18 further illustrate the sand erosion results by showing the labyrinth seal dimension and location at 0, 8, 24, and 117 hours of erosion. These evolution charts corresponds to the results previously discussed in the wear mode diagrams. It is important to distinguish between the two seals on the impellers and track their wear separately. The first type of labyrinth seal is located on the impellers discharge side and is coupled with the diffusers intake side as seen in Figure 17. The second type of labyrinth seal is located on the impellers intake side and is coupled with the diffusers discharge side as seen in Figure 18.

Figure 18 shows the even wear measured in the impellers and diffusers. The 3rd diffuser's discharge is not coupled with an impeller and showed no wear. Impeller 1 intake is coupled with the brass bottom flange seal and had more wear than impellers 2 and 3. The rate of wear increases as the location moves away from the motor coupling towards the pump inlet.

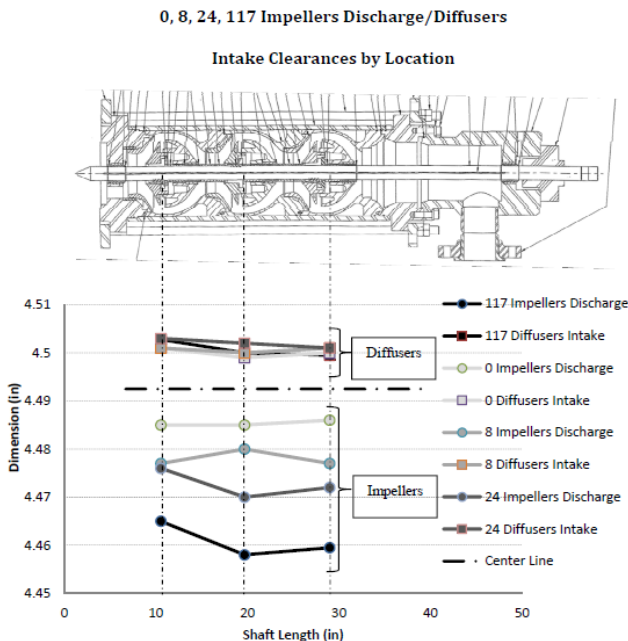
Figure 17. Impellers and Diffusers Evolution by Location (1)

in the diffusers in all stages after 117 hours of erosion. The impellers dimensions significantly changed with time. The rate of wear is more on impellers 2 and 3 than on impeller 1.

Figure 17 shows a negligible amount of dimension change

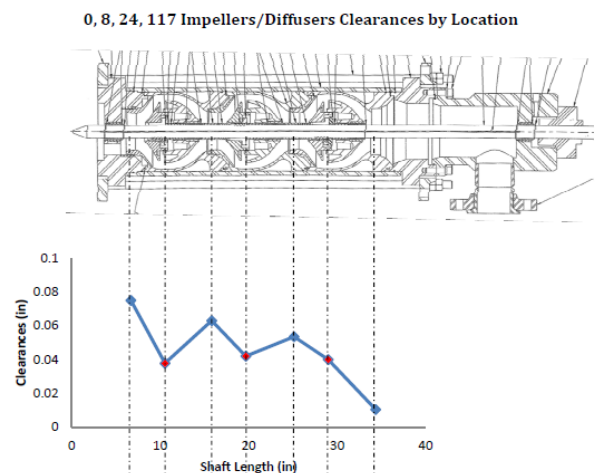
Figure 19. Impellers and Diffusers Clearances after 117 Hours by Location

Figure 19 presents the diametrical clearance of the seals after 117 hours of wear. The diffuser inlet seal has greater wear than the outlet seal.

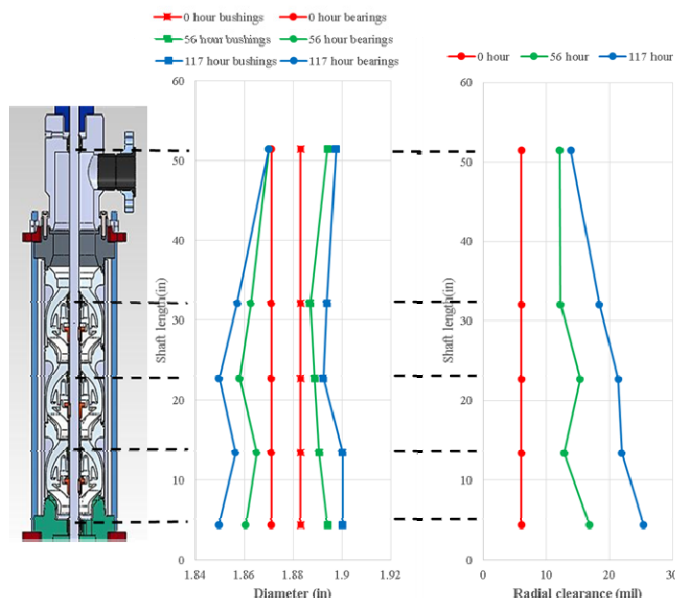
Figure 20. Bearing clearance changes due to erosion

The pump was disassembled at 56 and 117 hours of erosion. Figure 20 shows how the bearings eroded during the

study. Included are the OD and ID of the journal and bush as well as the net clearance. The cutaway of the pump shows the locations. The bearing wear decreases from the pump inlet (bottom of the pump) to the pump exit. The pump shaft is 1.5 inches in diameter. At the pump inlet, the maximum diametrical clearance was 0.050 inches resulting in a clearance to radius ratio of 0.033. The bearings were relatively ineffective at this point.

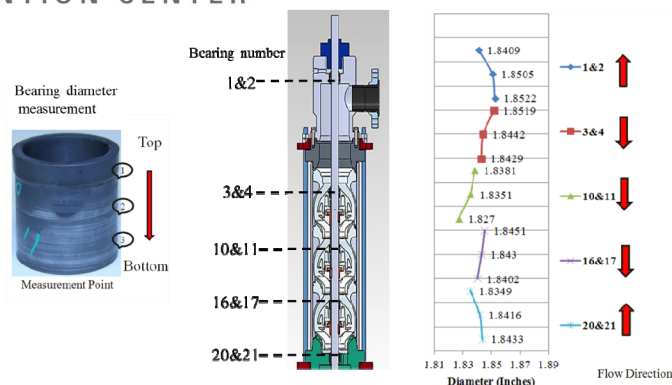
Figure 21. Bearing (journal) diameter variation along length. Red arrows show direction of flow.

Another interesting effect of the erosion is that the bearing (journal) diameter has more wear at the exit of each bearing than at the inlet as indicated by the smaller diameter, effectively generating a divergent taper. These data are shown in Figure 21. The arrows on the graphic indicate the direction of the leakage flow through the bearing. As the sand progresses through the bearing, it is initially crushed by the bearing as indicated by the circumferential grooves around the bearing. This produces smaller sand particles which have sharp fracture edges. These smaller particles work as an abrasive material to more rapidly erode the bearing and to provide a polished surface.

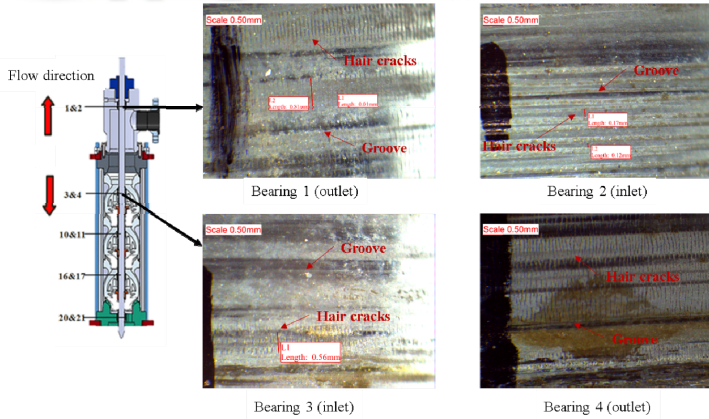
Figure 22. Microscopic examination of the bearing (journal) surface for the exit bearings at 117 hours.

Microscopic examination of the bearings is shown in Figures 22 and 23. These bearing assemblies had a radial clearance of 0.006 inch when new. The 100 mesh sand has an average size of 0.006 inch. Therefore the sand is able to enter into the bearing clearance. The four images are of two different bearing (journal) surfaces at different locations in the pump. For each location, one image is near the leakage flow's entrance and the second is near the exit. The two are different in that at the inlet the large grains of sand are crushed inside the bearing as the clearance varies in the azimuthal direction. The rotation of the shaft in the direction of decreasing clearance grabs the sand and drags it around the bearing. This is evidenced by the circular grooves in the bearing surface. By the time the sand exits the bearing clearance, the sand size has been reduced by the crushing affect producing smaller sand grains with sharp edges. The sand has the effect of a polishing compound. A very interesting result is that the outside surface of the bearing is cleanly removed revealing that the inner portion of the bearing has a well ordered array of stress cracks covering the entire surface. It is hypothesized that these cracks are caused by thermal stress occurring when the bearing surfaces rub, heating the surfaces causing them to expand. Due to the low thermal conductivity of the tungsten carbide, the inner regions remain cool and are fractured due to the expansion of the outer surface. Since this pump was operated with less than a 20F temperature variation, thermal shock due to fluid temperature variations were not possible. The depth of the fine cracks has not been established at this point but if they significantly penetrate the radius of the bearing, the structural integrity of the bearing will be greatly reduced. More study is required to evaluate this affect. The Turbomachinery Laboratory is constructing a bearing test facility to study this in detail.

From the above discussion of the test results after 117 hours, it can be concluded that the most critical component of the ESP is the rotor. It includes the shaft, impellers, sleeve bearings, and sleeve spacers. The largest amount of wear was detected on the impeller seals and bearings. This affected the pump's overall performance. The rotor waterfall plots indicate that the rotor vibration has locked at the first critical speed of the rotor. This caused an increase in the rotor components rate of wear and the detection of damage to the components. It is recommended that the generic tungsten carbide bearings used in ESP pumps be replaced with bearings that are more tolerant to rubbing (resulting in thermal stress cracks) and modified in design to help flush sand from the bearing before severe gouging of the bearing surface occurs.

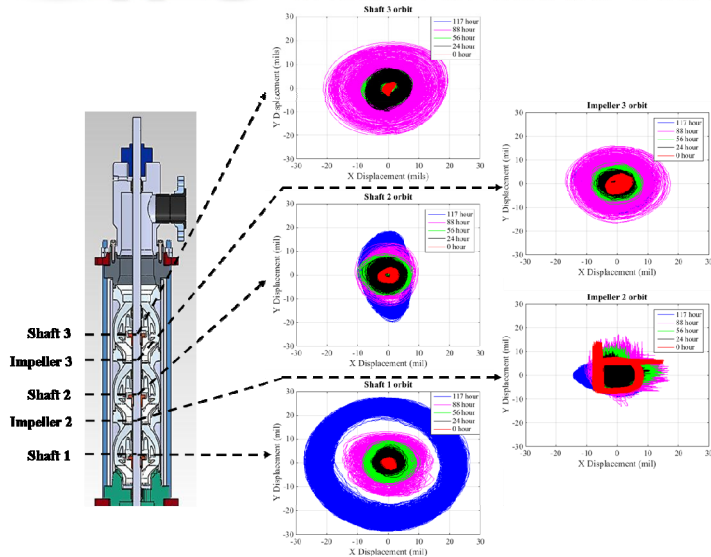
Figure 26. Pump components orbits at various stages of erosion.

Figure 26 presents orbits for the five axial locations instrumented recorded at different times during the erosion process. The first two impellers were monitored along with the three bearings that support the two impellers as shown in Figure 24. Impeller 2 has spikes on it since flat spots were machined onto it to facilitate rotor angle measurement. The shaft locations are for the shaft bearings' motion with the impeller being the orbit of the impeller located between the bearings in the position indicated in Figure 24.

As Figure 20 has indicated, the bearing at the pump inlet (Shaft 1) has the most wear and the orbits tend to be circular. Shaft 2 has a significantly smaller orbit which begins relatively circular but become elliptical at the end of the study. Shaft 3 bearing maintains a relatively circular orbit with a maximum amplitude between Shaft 1 and Shaft 2 bearings. The interesting observation is that the two impeller seals have ultimate orbits smaller than Shaft 1 and 3 while Shaft 2 is smaller. It appears that as the wear progresses the impeller seals are starting to replace the bearings as the load carrying component. Figure 27 combines the data of the physical diameters of the bearings and seals into one figure. It can be seen that as the erosion progresses the clearance of the bearings exceed the clearance of the impeller seals by a considerable amount. The impeller seals ultimately reach a radial clearance of 20 mils while the bearing range from 26 to 32 mils. This is further evidence that the impeller seals have become the pump bearings.

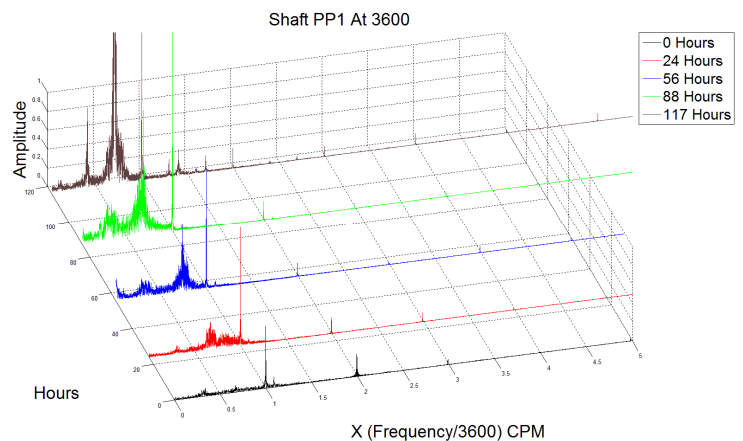
Figure 28. Shaft 1 (PP1) orbit frequency content variation with erosion.

The evolution of the frequency content of the pump vibrations due to erosion as indicated by the PP1 proximeter probe for the Shaft 1 location are shown in Figures 28 and 29. Water fall spectra of how the vibration of the pump changed with erosion time is presented in Figure 28 for one of the proximeter probes. At the start, the primary vibration is at the pump speed with a 2X harmonic and a slight indication of 1/3 and 2/3 components. As wear progressed, the sub harmonic components increased with the 2/3 component becoming dominant at the end of the test. Also included in Figure 29 is a ramp up water fall plot showing how the 2/3 harmonic tracks with the speed of the pump.

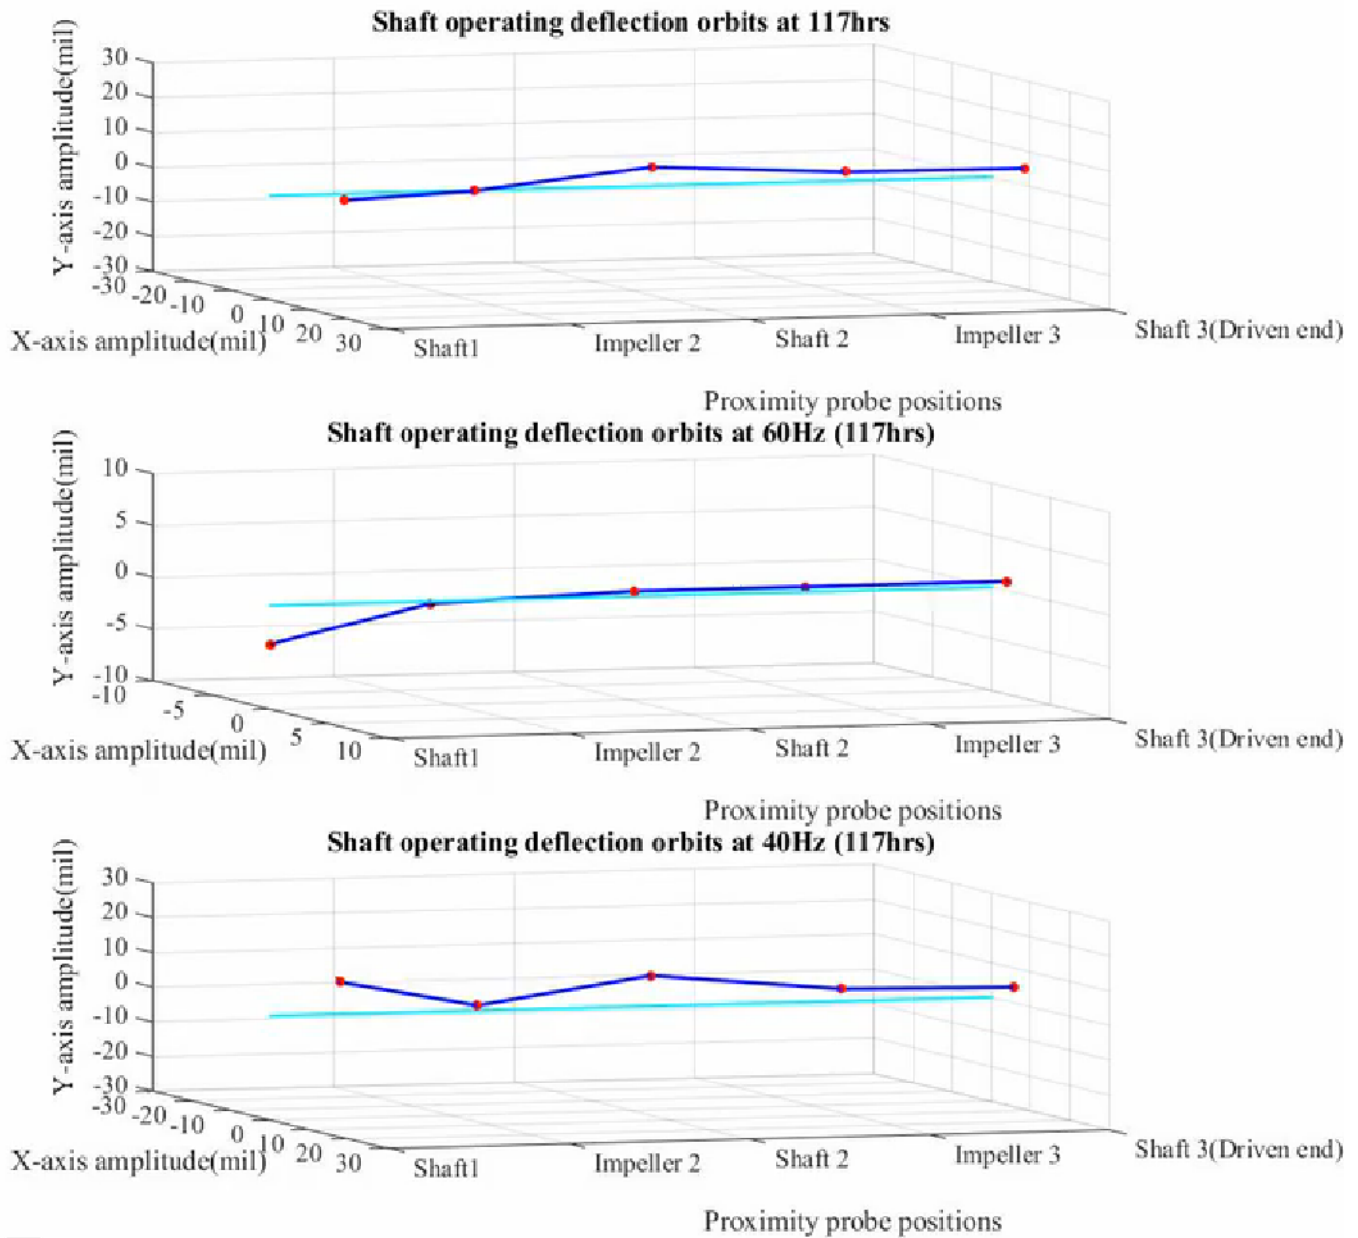
Figure 34. Rotor orbits at 117 hours.

Figure 34 presents the results at 117 hours. The axis scales of the top and bottom graphs are three times larger than the center (60 Hz) scale. At this point the whirling (40 Hz) mode dominates the vibration of the pump. These data also clearly show that the orbits of the shaft at the bearings are considerably larger than the orbits of impellers 2 and 3. This indicates that the impellers have essentially become the bearings.
